UNITED STATES
DEPARTMENT OF THE INTERIOR
BUREAU OF MINES

Subject: Investigation of minor coal outburst accident, Road 526
Section, Dehue Mine, Youngstown Mines Corporation, Dehue,
Logan County, West Virginia, October 25, 1961

MINOR COAL-MINE OUTBURST ACCIDENT
THE YOUNGSTOWN MINES CORP.
DEHUE MINE
DEHUE, LOGAN COUNTY, WEST VIRGINIA

Sketch A

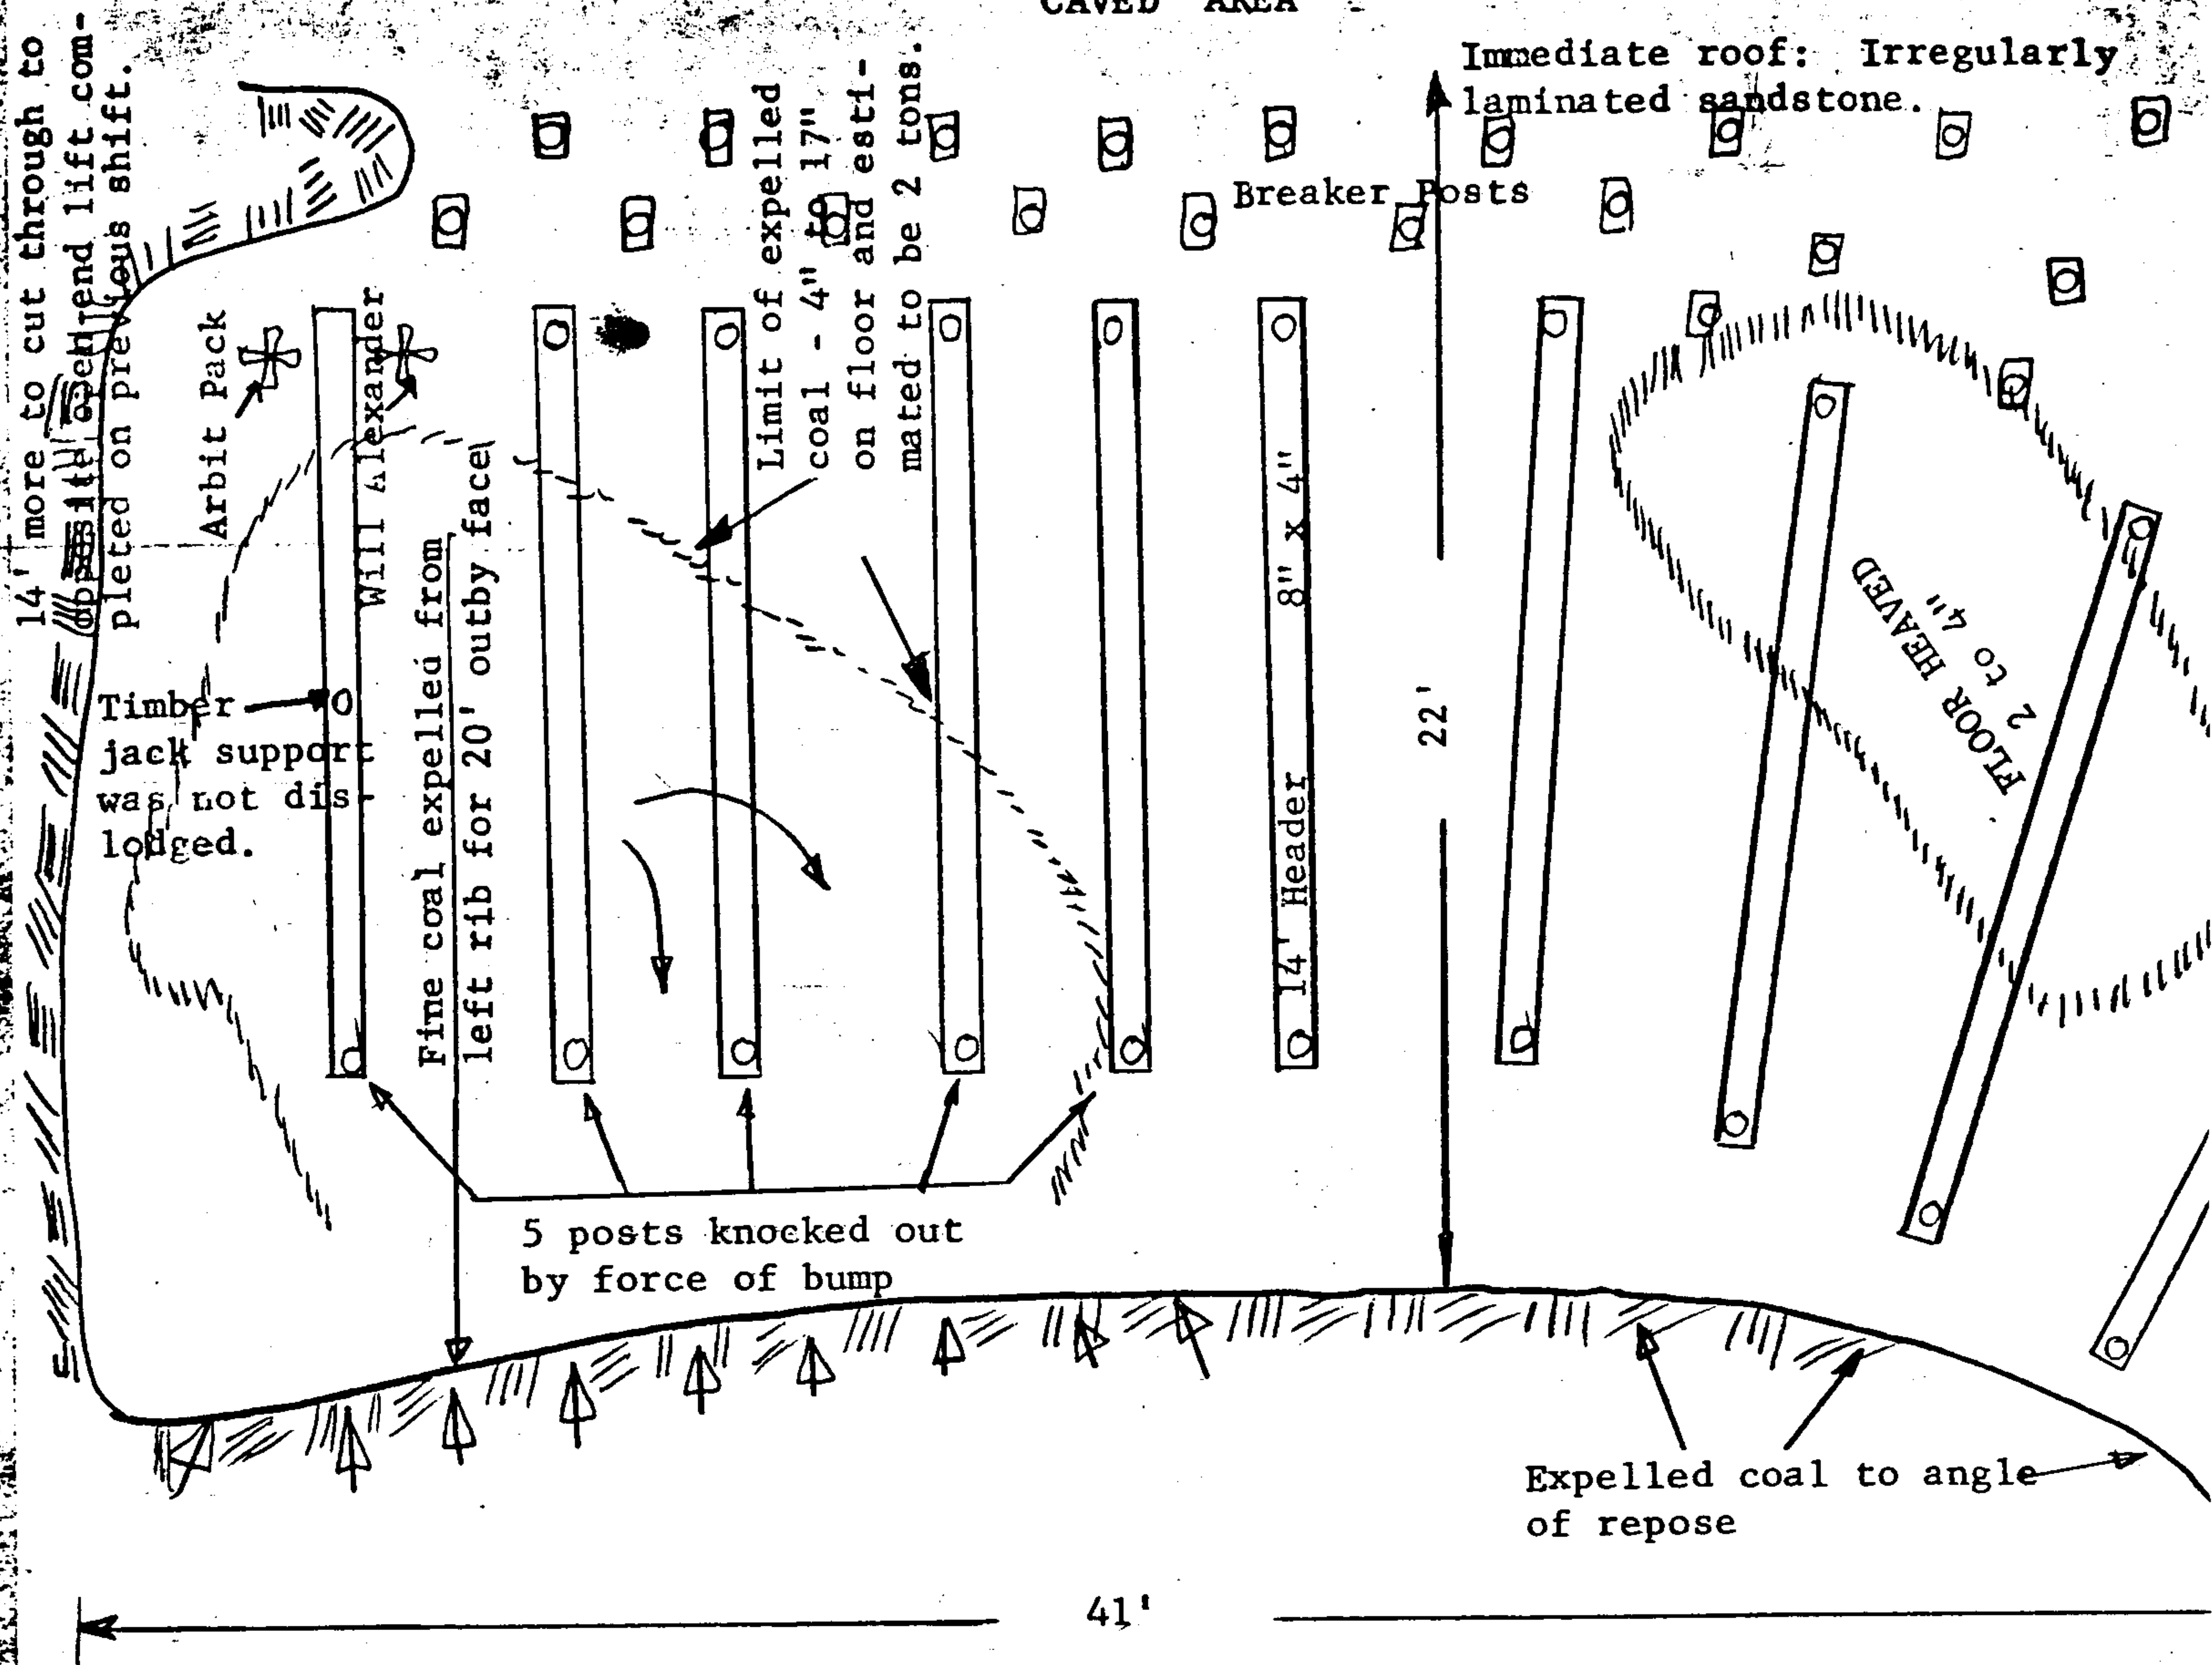
The outburst occurred in an open-end pillar lift off the crosscut side of No. 5 pillar (actually the crosscut side of Road 526-D entry). The No. 5 pillar was originally approximately 62 feet square; however, at the time of the outburst, the pillar had been reduced in dimensions by an open-end lift driven the previous day across the back of the pillar from the No. 4 entry (Road 526-D) and by the active lift involved in the outburst and which lacked 14 feet from cutting into the completed lift on the opposite or inby side of the pillar.

Location of the men and equipment and the extent of mining in the Road 526 Section at the time of the coal outburst are indicated in Sketch B and the specific area involved in the outburst is indicated in detail in Sketch A. From Sketch A, it will be noted that the pillar lift had been driven 41 feet along the gob side of the pillar and lacked 14 feet from cutting into the completed alternate lift on the opposite side of the pillar. It will further be noted that the left rib of the open-end pillar lift had not been mined straight (on a 90-degree angle from the crosscut side of the pillar),

but on the contrary, had been angled too far to the left ("hogged out") with a fender of coal 3 to 5 feet in thickness left unmined on the right side next to the gob. This fender, under the circumstance, could have acted as a constraining factor within the pillar. Reportedly, 4 cuts of coal, including the cut cleaned up by the night-shift crew on the evening the bump occurred, had been mined in the pillar lift.

Effects of the outburst were confined to the immediate vicinity of No. 5 pillar as indicated with the greatest force being expended on the left side of the No. 5 pillar split and to a lesser degree in the face of the split as indicated by the expulsion of coal into the roadway. Timbers were knocked from under one end (next to the left rib line) of the 5 inby crossbars in the pillar lift by a combination of flying coal and the resultant shock wave; the floor was affected slightly at the entrance to the pillar split and to a greater degree in Road 526-D between Nos. 4 and 5 pillars. At the time of the outburst, Pack was assisting Alexander in sawing a timber and had his back toward the face of the pillar lift. He was thrown off his feet by the stress wave and received injuries as previously described. Alexander, who was within 3 feet of Pack at the time of the outburst, was not injured. Information from witnesses indicated that considerable dust was thrown into suspension in the immediate vicinity of the bump; however, the foreman reported that he did not detect methane with a flame safety lamp within the affected area immediately after the bump. The shock wave and tremor from the outburst evidently were not severe. The night mine foreman who was near the loading point (200 feet from the outburst) said he heard the sound of the outburst but did not perceive the tremor or shock wave. The section foreman was in the No. 2 entry when the outburst occurred and stated that he was not aware a bump had occurred until he was notified of the occurrence by an employee. The loading-machine crew members stated that they did not hear the bump but felt the floor tremor. The loading machine was operating at the time of the outburst in No. 4 pillar. A cut of coal had been blasted in No. 2 pillar and the cutting machine had cut the face of No. 1 pillar lift 20 and 10 minutes prior to the outburst, respectively.

1. Pillars should be extracted in a straight line. Irregular pillar lines result in excessive pressures on any pillar line points thus formed. Experience has shown, however, that the lead (top end) of a pillar line can be kept slightly in advance without adverse affects.

2. The adopted pillar extraction sequence (numbered cuts) should be followed in mining the individual pillars.
3. The pillar lifts should be mined open-ended and be driven straight. (In some instances, where the roof is broken and may present a roof-fall hazard, a thin wing or fender is permissible.)

4. "Hogging" or digging the "loose" coal from the rib line or the face of lifts of stressed pillars usually results in tight corners outby the extraction line thus creating a potential bump condition, and such practice and/or violation of this company rule should not be permitted.
